# ANNUAL REPORT FOR 2005

**Bethel Church Mitigation Site**

**Yadkin County**

**Project No. 6.779004T**

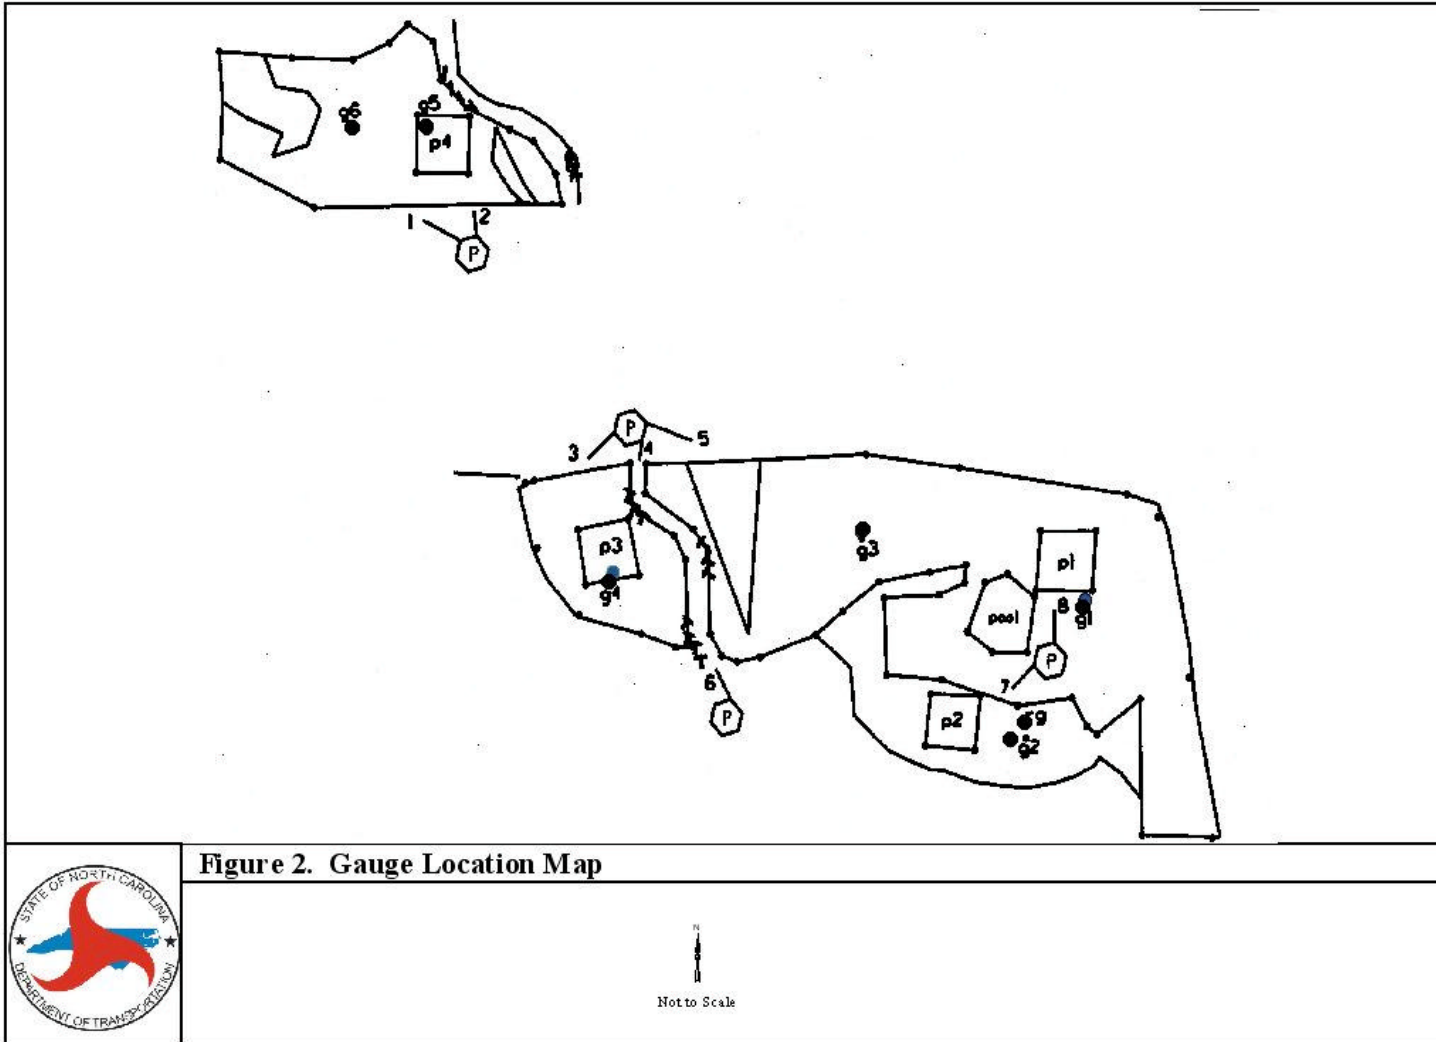
In March 2001, six groundwater gauges were installed across the site (Figure 2). The automatic monitoring gauges record daily readings of groundwater depth. This represents the fifth growing season that the monitoring gauges have been in place since construction of the site.

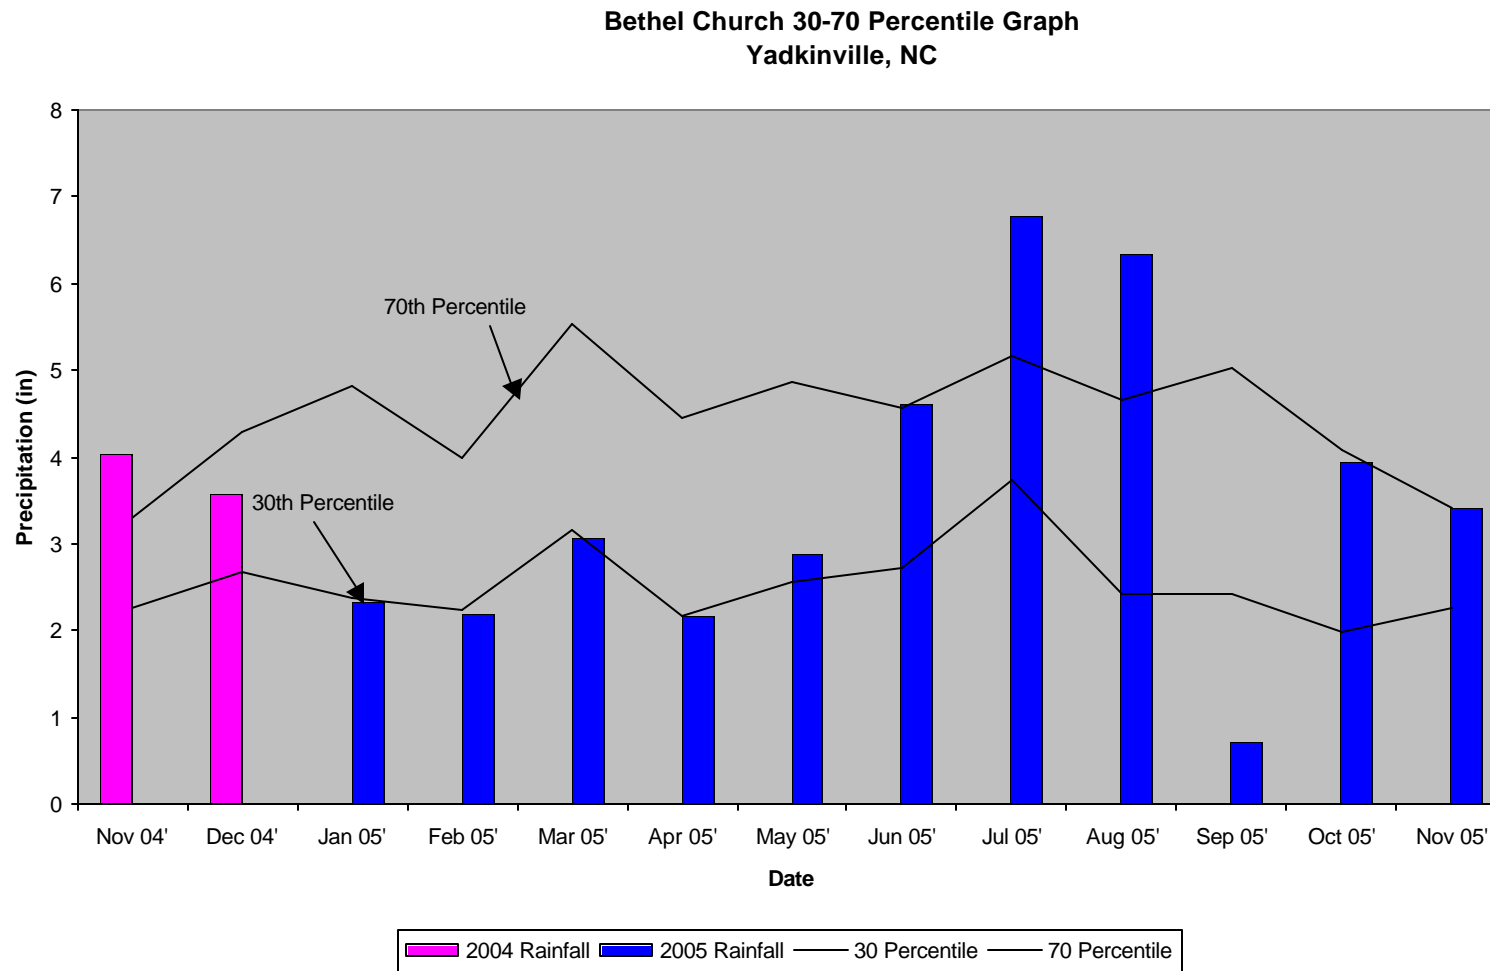
**Figure 4: 30-70 Percentile Graph**

Figure 4 is a comparison of monthly rainfall for the period of November 2004 through November 2005 to historical precipitation (collected between 1974 and 2005) for Yadkinville, North Carolina. This comparison gives an indication of how 2005 relates to historical data in terms of climate conditions. The NC State Climate Office provided all local rainfall information.

For the 2005-year, November ('04), July, August, and November experienced above average rainfall. The months of January, February, April, and September recorded below average rainfall for the site, while December ('04), March, May, June, and October recorded average rainfall. Overall, 2005 experienced an average rainfall year.

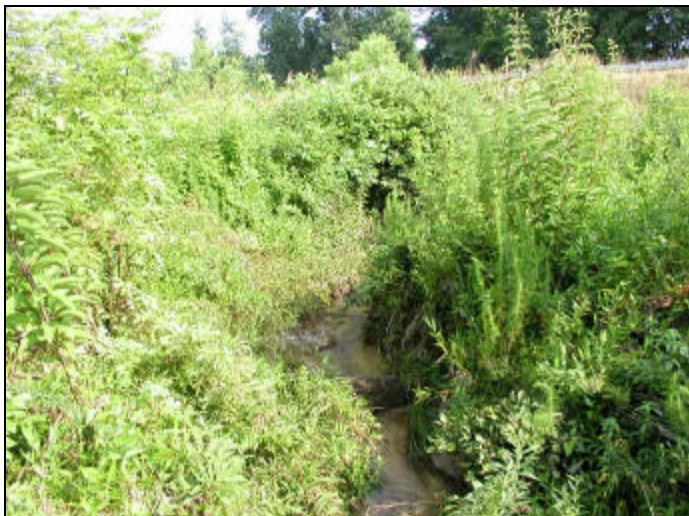
Photo 9 (Stream)

The stream channel was visually inspected during the annual vegetation monitoring of the site. A bankfull event had been noted since the last monitoring period. The streambanks were highly vegetated with herbaceous species, black willow, silky dogwood, and tag alder. The channel was stable throughout the entire length. Photos 9 through 14 show the conditions of the stream. No maintenance actions are necessary.

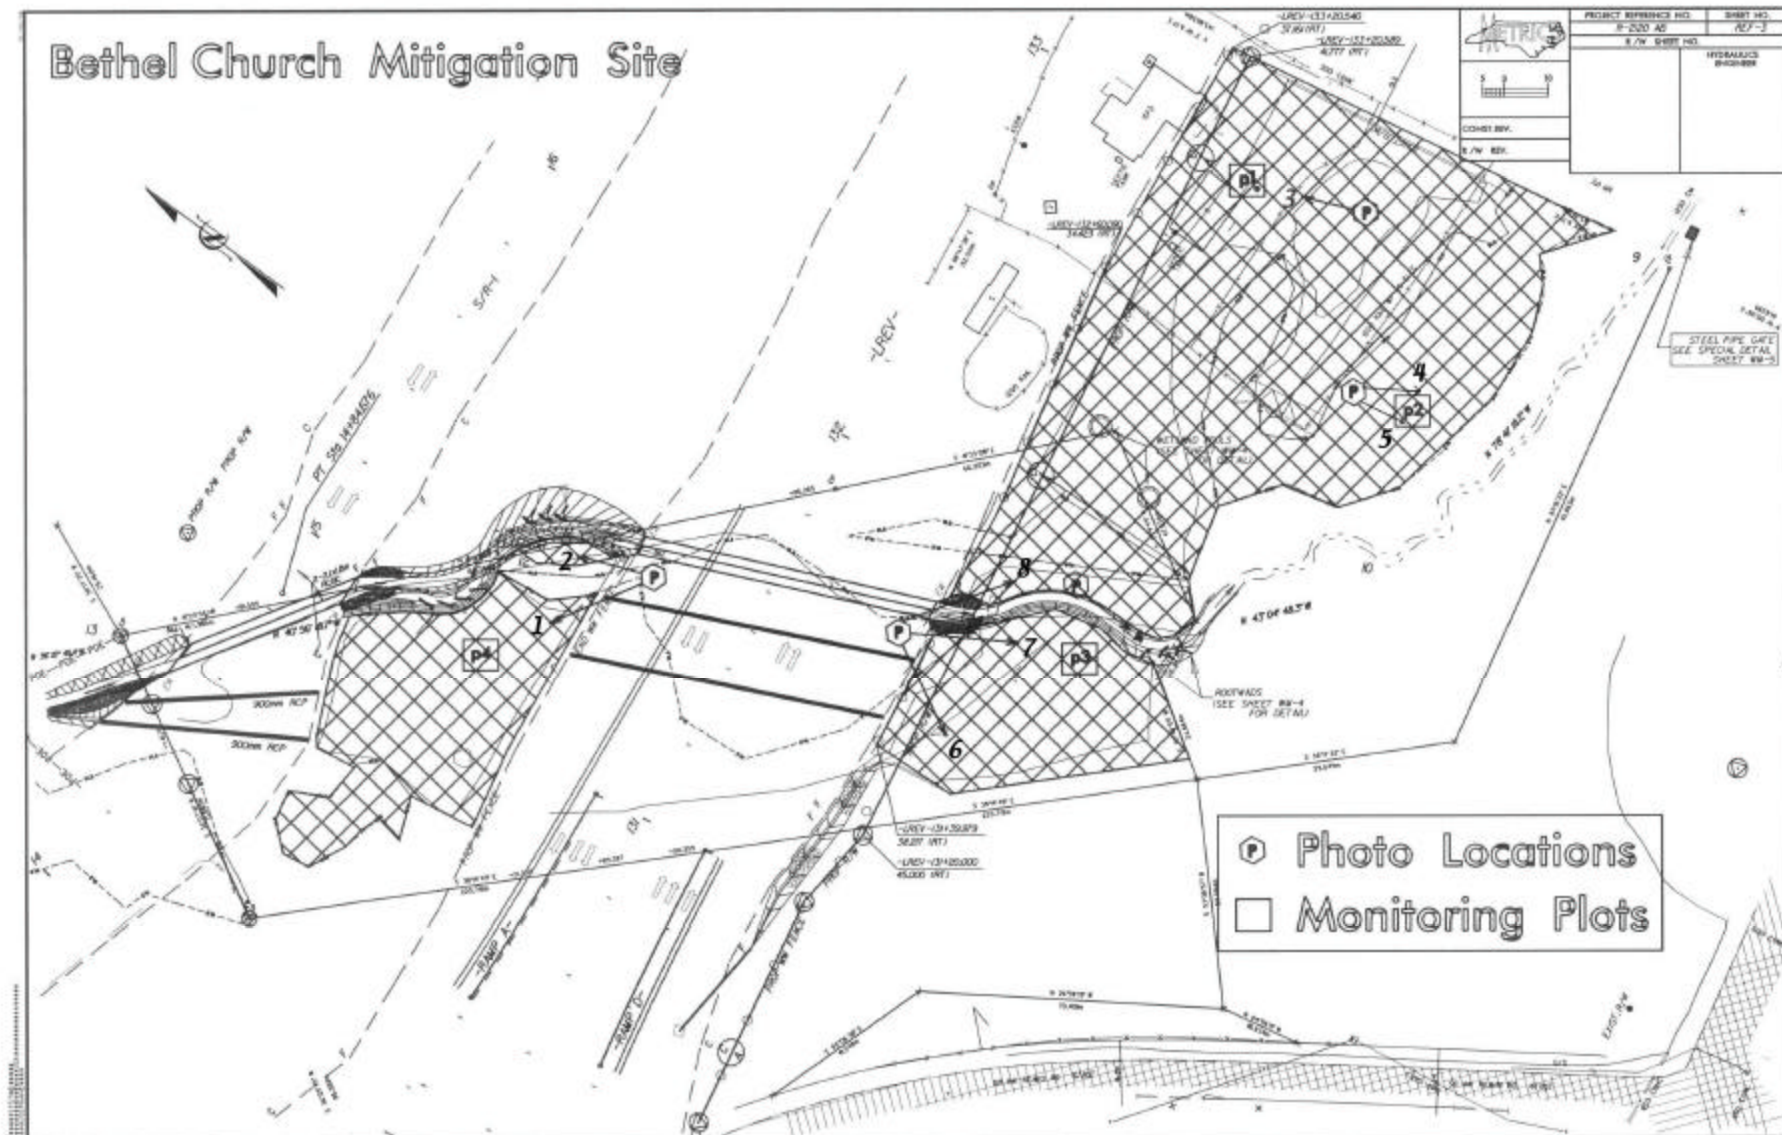
**Bethel Church Mitigation Site**

This map illustrates the Bethel Church Mitigation Site, showing the locations of photo points (P) and monitoring plots (P1, P2, P3, P4). The site is characterized by a large, irregularly shaped area with a cross-hatched pattern, likely representing a wetland or sensitive habitat. The map includes various geographical features, roads, and infrastructure. Key elements include:

- Photo Locations (P):** Marked with a circle containing the letter 'P'. Locations are numbered 1 through 8.
- Monitoring Plots (P1, P2, P3, P4):** Marked with a square containing the plot number.
- Legend:** A box in the lower right corner defines the symbols: a circle with 'P' for Photo Locations and a square for Monitoring Plots.
- Scale and Orientation:** A north arrow is located in the upper left. A scale bar is provided in the upper right, indicating distances in feet (0 to 100).
- Site Details:** The map shows various roads, including a main road labeled 'R 47 OF 48.5' and a 'ROADWAY (SEE SHEET BW-4 FOR DETAIL)'. It also depicts a 'STEEL PIPE GUY' and 'HYDRAULIC STRUCTURE'.
- Topographic Information:** Elevation points are noted, such as 'ELEV -131+00.540 50.00' and 'ELEV -131+00.000 45.00'.
